Manhole Inspection Summary

Manhole # S35II_012MH

Insp Date: **3/13/07 9:19 AM**

Location Address: **1701 CALVERT ST**

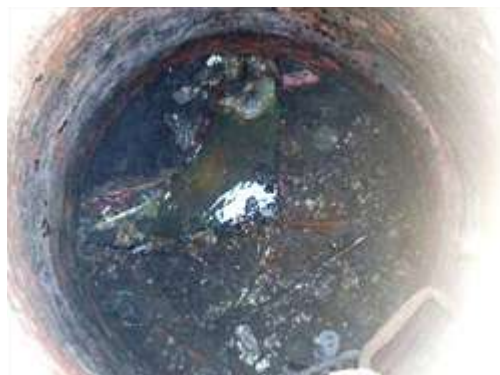
Top View

Corroded and missing steps. Evidence of surcharge - Bench debris. Channel debris.

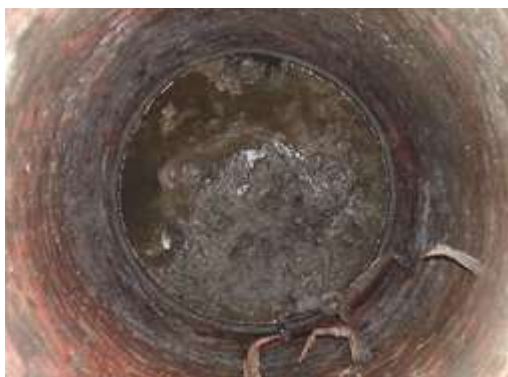
Active surcharge - 1st visit

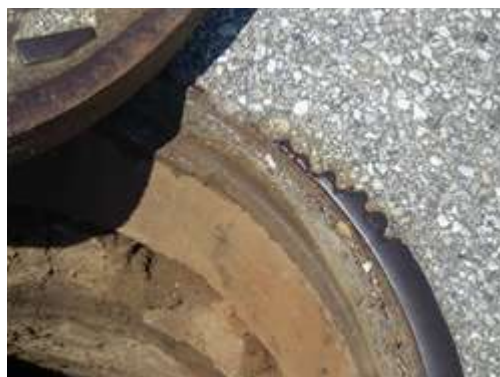
Defect

Worn frame. Frame leaks. Frame offset. Adjustment infiltration.

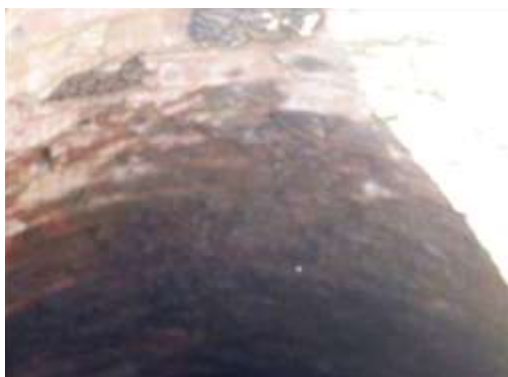
Defect

Corbel and Barrel infiltration.

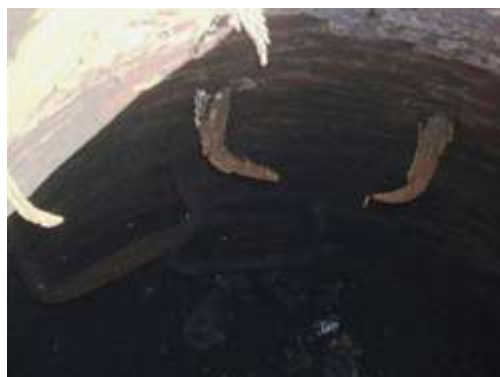
Defect

Corroded and missing steps.

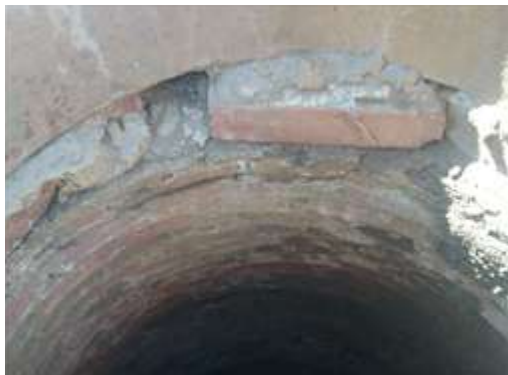
Defect

Frame leaks. Frame offset. Adjustment deterioration, loose brick and infiltration. Corbel and Barrel infiltration.

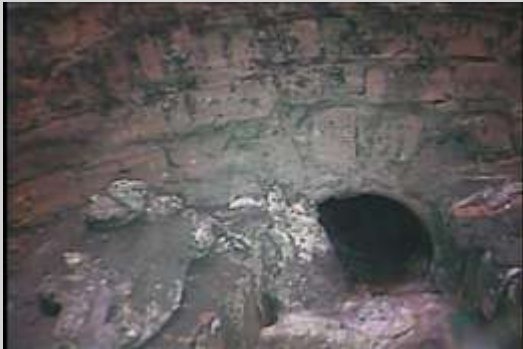
8 in. Circular Gravity Sewer Pipe Out @ 12 O'Clock

Invert Depth: **9.27** (ft.) Flow Characteristics: **Slow**

Deposits: ☐ None ☒ **Mud** ☐ Sludge ☒ **Debris** ☒ **Grease**

Silt Depth: **1** (in.) Deposits Extent: **Light**

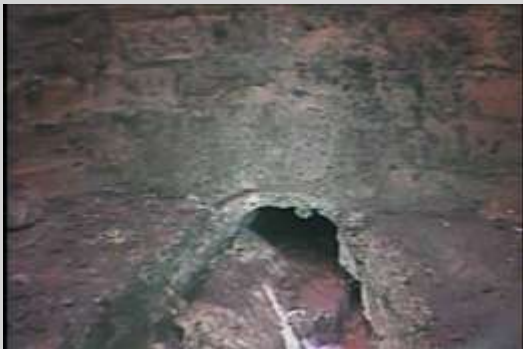
8 in. Circular Gravity Sewer Pipe In @ 9 O'Clock

Invert Depth: **9.02** (ft.) Flow Characteristics: **Slow**

Deposits: ☐ None ☒ **Mud** ☐ Sludge ☒ **Debris** ☐ Grease

Silt Depth: **4** (in.) Deposits Extent: **Medium**
